Attachment A: Digital Images

May 5th, 2008

BOE Building 19th Floor Men's Rest Room Assessment
Sacramento, CA

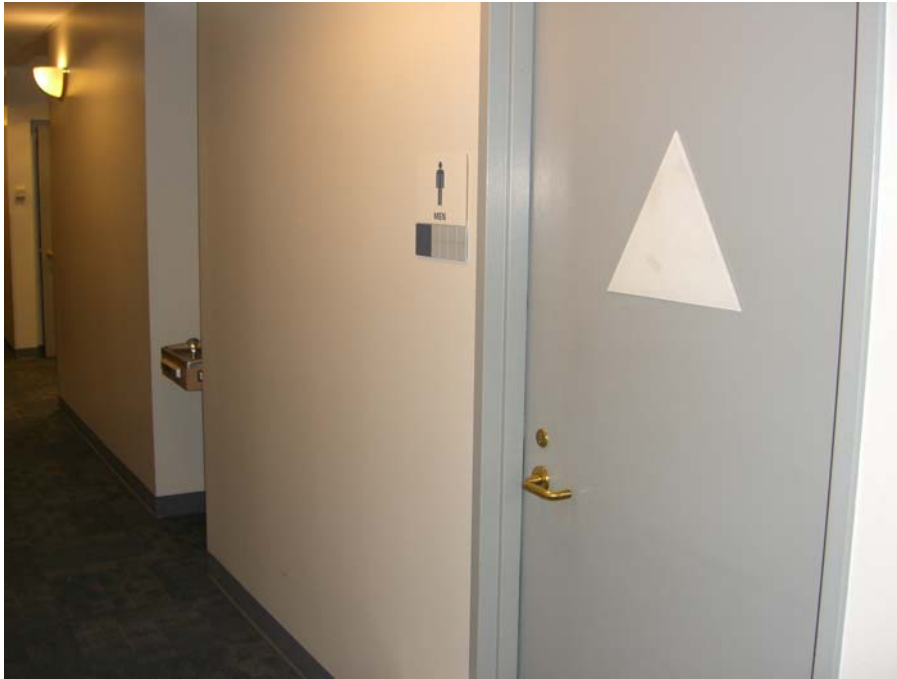
- 1) Image of 19th Floor Man's Restroom access door at time of assessment of BOE Building (Subject Building) located at 450 N Street, Sacramento, California.

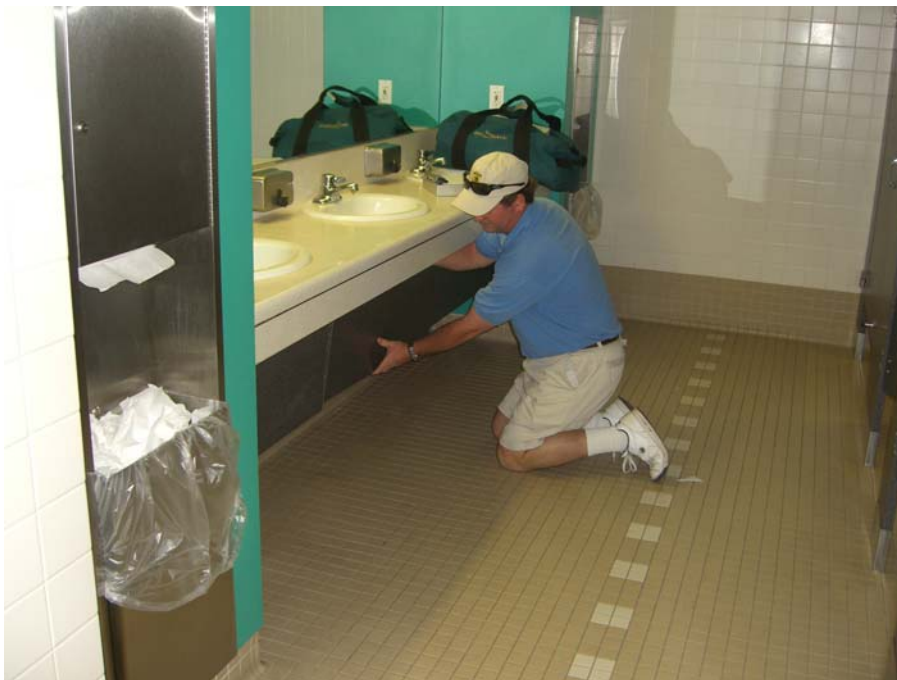
- 2) Image of JLS representative, Rick Boggs removing center panel to gain visual access to moisture impacted materials at time of preliminary assessment performed on May 1st, 2008.

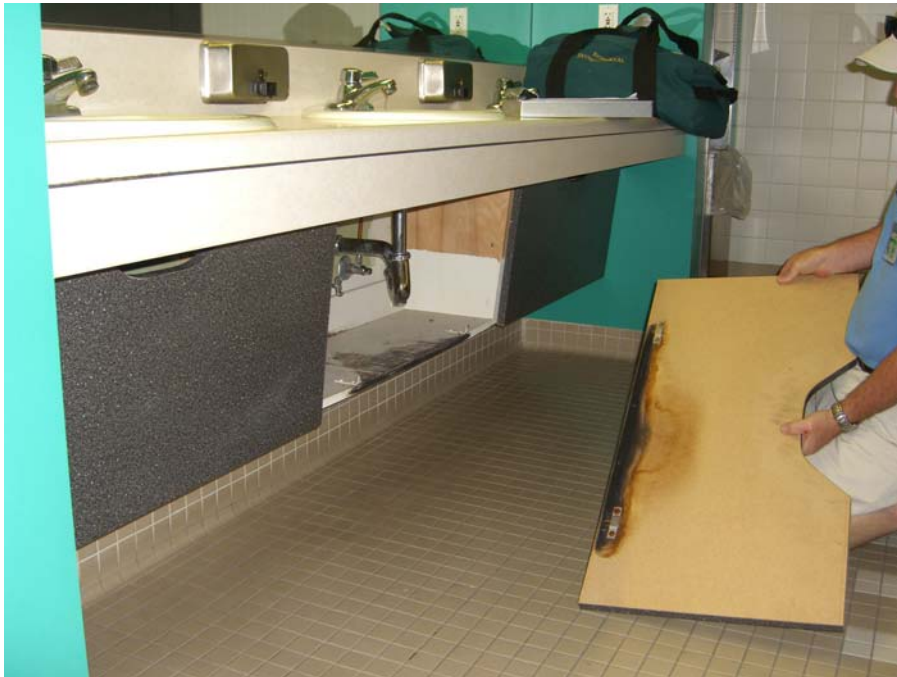
- 3) Image of panel and cabinet staining present with indications of historic moisture staining present on building materials.

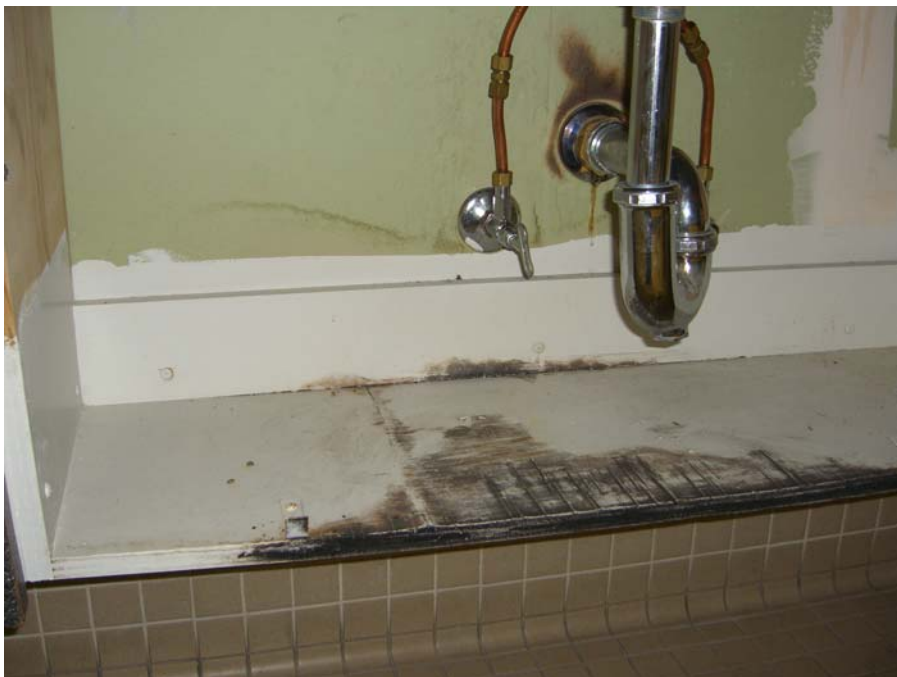
- 4) Close-up image of stained cabinet and sheetrock materials associated with historic moisture release from sink area systems.

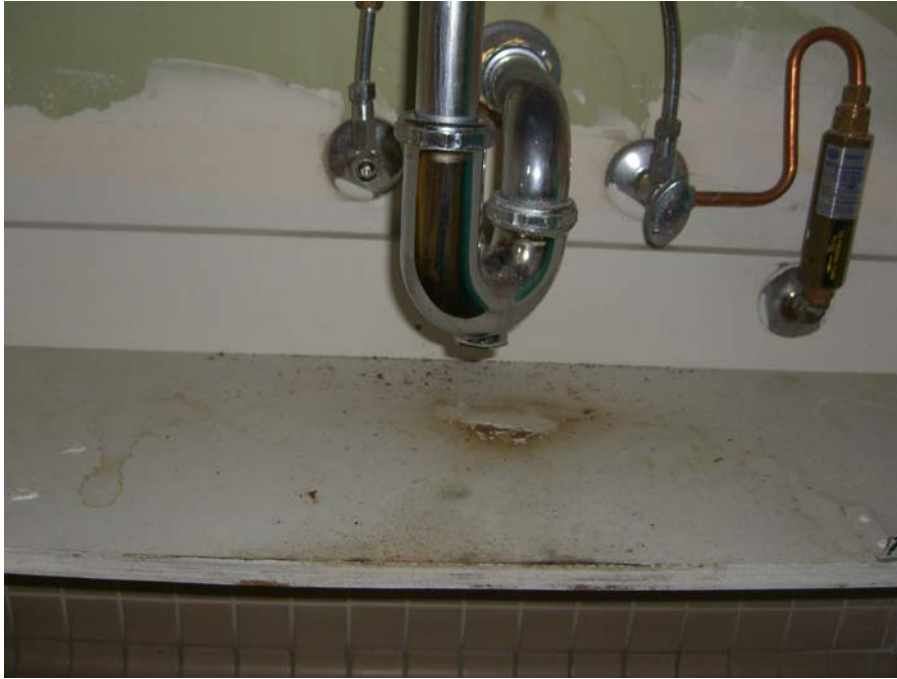
- 5) Image of sink cabinet cavity to right of basin area. Similar staining present within cabinet materials.

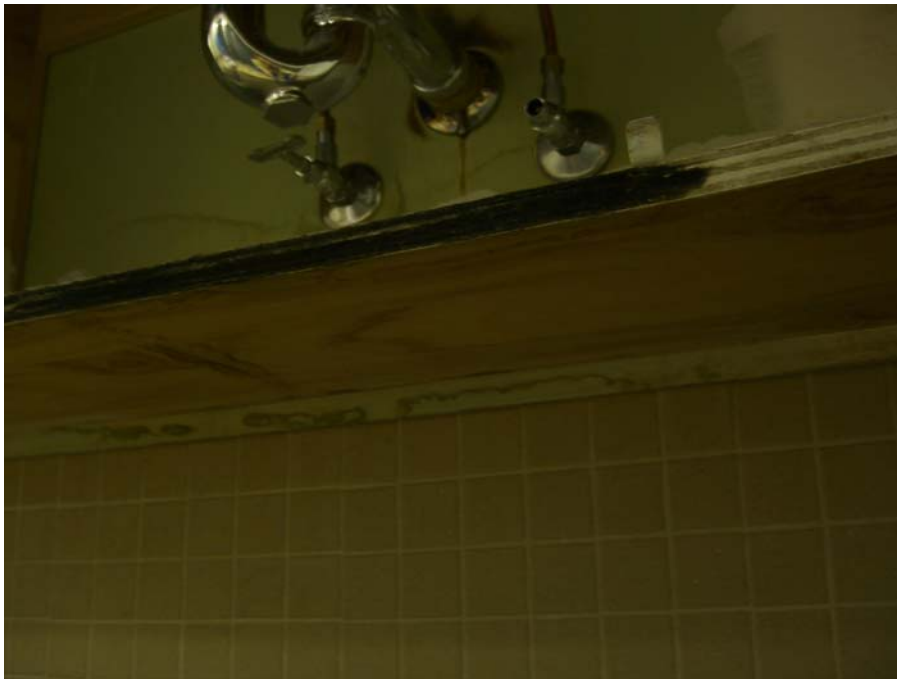
- 6) Image of area located beneath cabinet where staining is currently present on wood materials located above tile level.

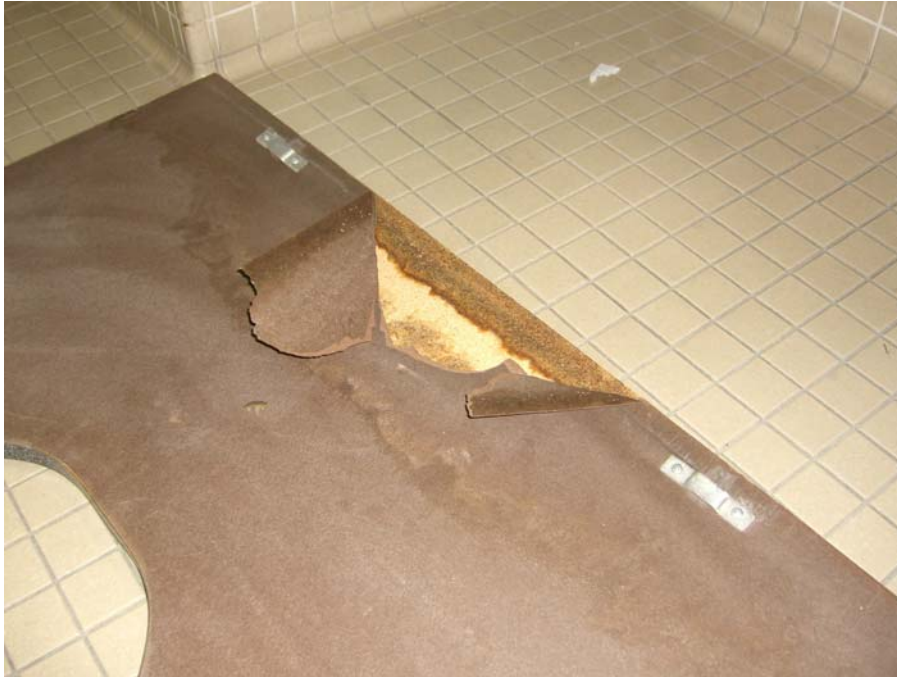
- 7) Close-up image of stained paper and particle board materials present within left side sink cabinet access panel materials.

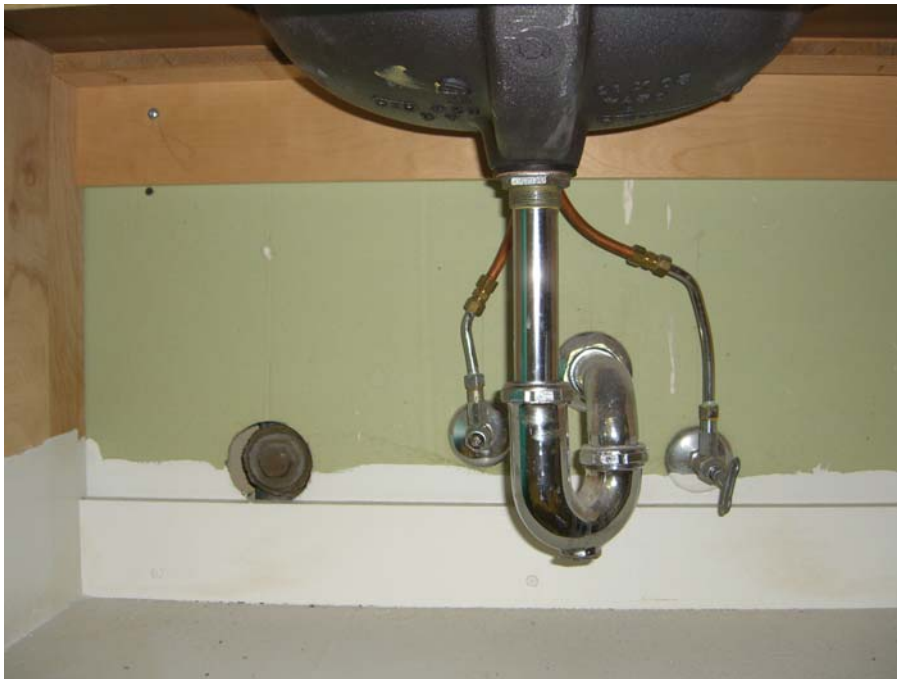
- 8) Image of left sink cabinet area with minimal staining present on exposed building materials.

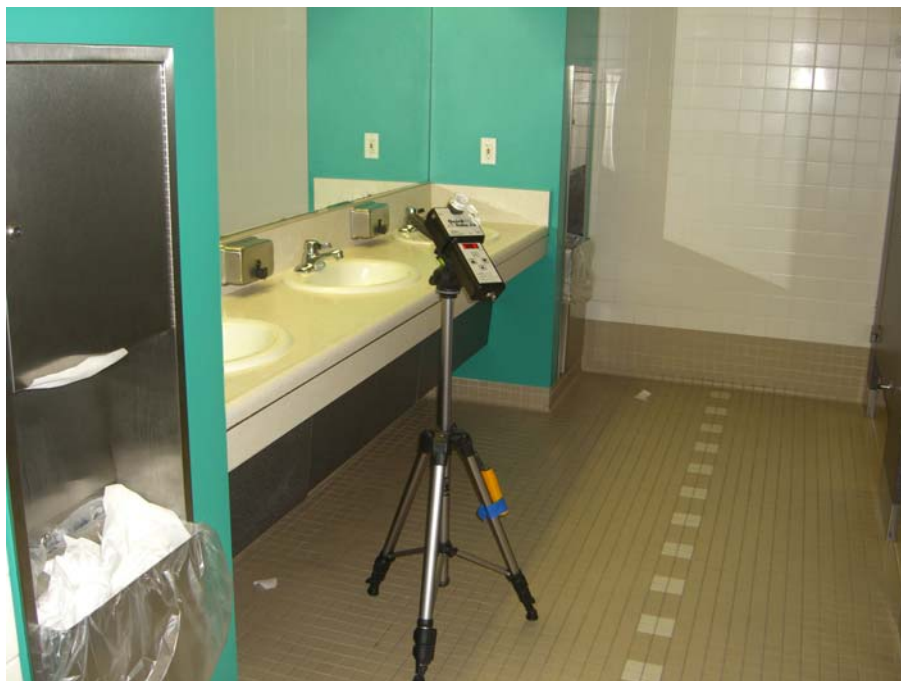
- 9) Image of air sampling equipment utilized within men's rest room on May 5th, 2008 to assess potential exposures during normal occupied times.

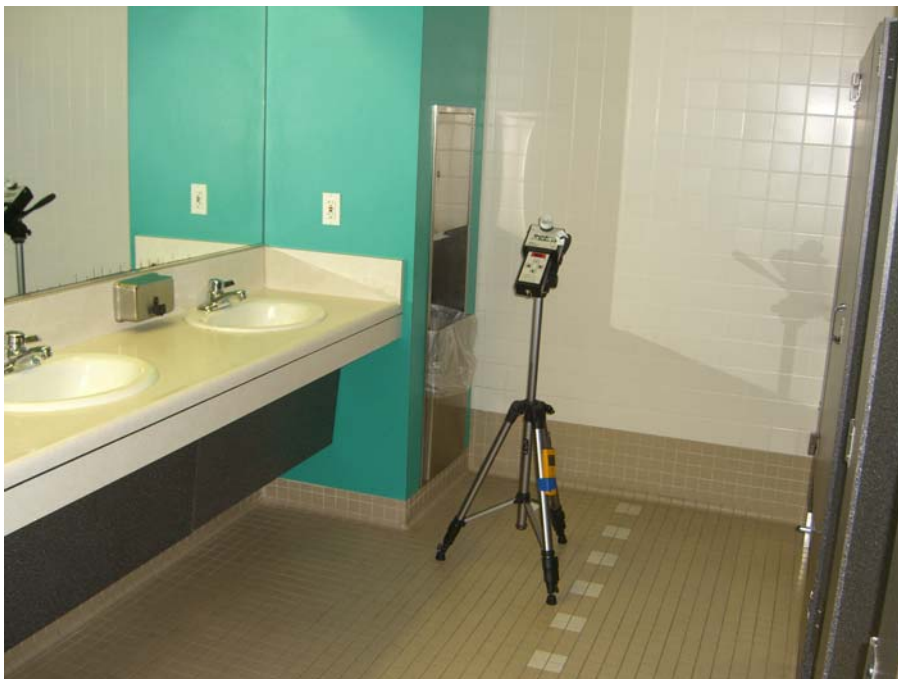
- 10) Image of second interior airborne sample collected within men's rest room area at time of supplemental assessment performed on May 5th, 2008.
